CHALLENGE: Special Nuclear Material Package Inspections – Ex-situ

Sellafield Ltd is responsible for the storage of Special Nuclear Materials (SNM) that are a legacy of 60 years of reprocessing activities on the Sellafield site. To provide confidence that SNM packages remain safe for continued storage within Sellafield's stores, it is necessary to obtain reproducible visual images of the entire exterior of the packages. This is performed ex-situ and does not require radiation hardened equipment. The aim is to identify structural changes through storage of precisely located visual images that can be referenced against at points in the future to monitor change. The essence of this challenge is to find a precise, reproducible and possibly automated method for gathering inspection images.

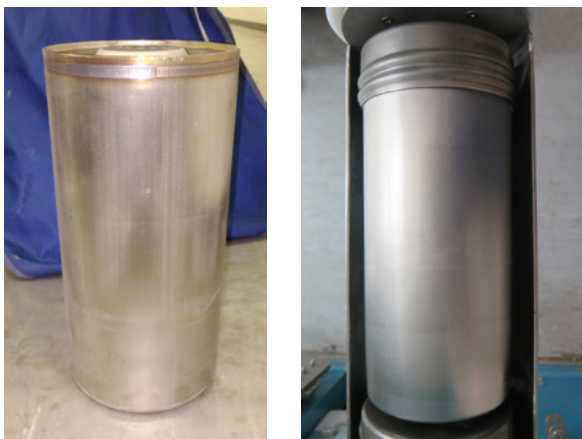
Figure 1: Images of typical SNM canisters, the left hand image is a welded SNM package and the right hand image is a screw-top 'overpack' SNM package.

SNM packages are cylindrical and vary in size, with a typical length of 310mm and diameter of 152mm and typical mass of around 10Kg (maximum 20kg). An SNM package typically consists of a lidded outer body (outer can), within which resides an inner sealed body (inner can) which contains the SNM. Both the inner and outer parts of the packages are constructed from 316L stainless steel with some having additional LDPE protective layers. Sellafield has around 30,000 such packages on site and these mainly fall into two key populations as illustrated in Figure 1.

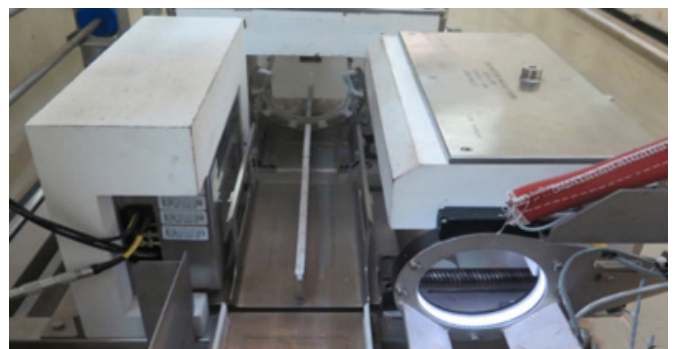
Figure 2: Image of a typical ex-situ inspection area. SNM packages rest on the central rail between the shielding blocks.

SNM packages may be inspected both in-situ and ex-situ, although this does depend on the layout of each SNM store. During package inspections, it is only the outer surface of the package that is inspected. **This challenge is purely focused on ex-situ inspections.** An ex-situ inspection involves the removal of an SNM package from the store and transportation to the inspection area, such as the one shown in Figure 2, where an operator performs the inspection routine.
